HOME INSPECTION REPORT

42629 Calandri Lane Lancaster Ca.

11/08/2018

STR1266

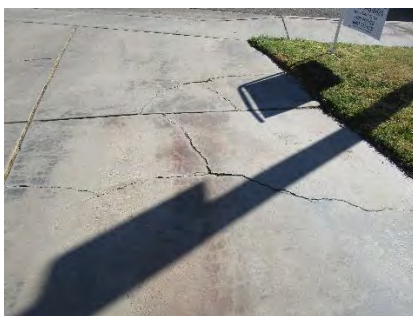
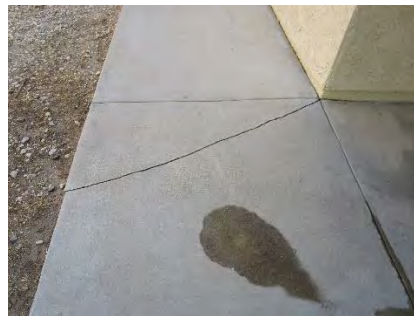
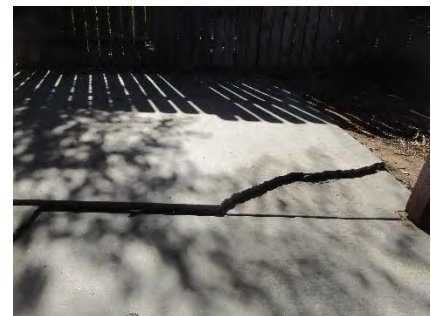
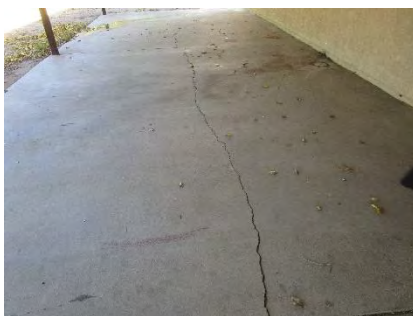
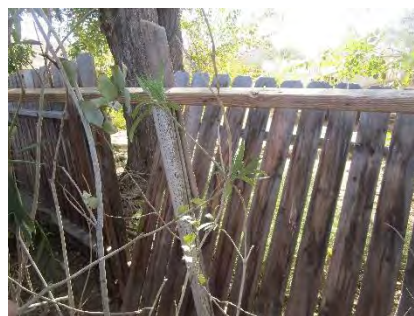
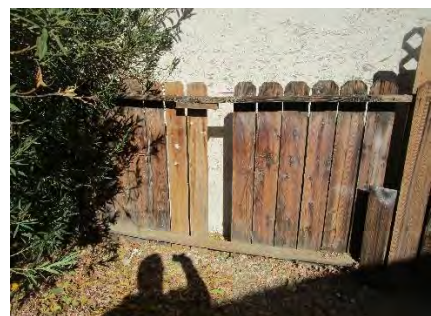
Driveway concrete have some larger cracks, recommend sealing, fill and seal as needed.
 Patio concrete has large cracks and concrete is lifting on south west corner, recommend repair and seal cracks, repair as needed.
 Recommend insulation on hose bib pipes exposed to cold weather on north side of home, install as needed.
 Backyard wood fence requires repairs, repair as needed.
 Recommend Anti-siphon valves installed on hose bibs, install as needed.

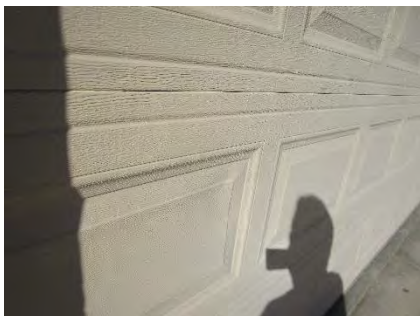
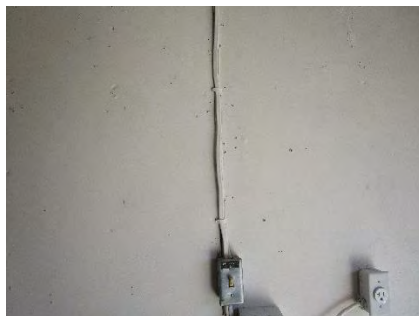
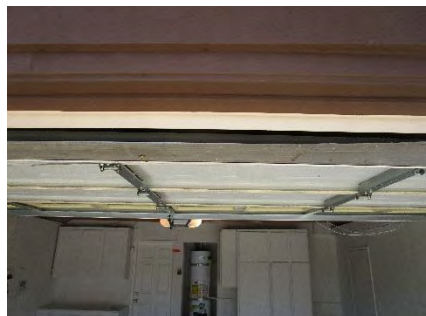
Garage door lower weather-stripping requires replacement, repair as needed.
 Garage double metal door has a minor dent, repair if needed.
 Recommend in garage replacing one receptacle with the GFCI type, replace as needed.
 Romex feeding receptacle's on garage walls is not approved for surface mounting, recommend approved pipe, repair as needed.

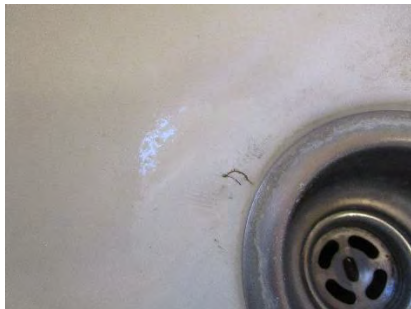
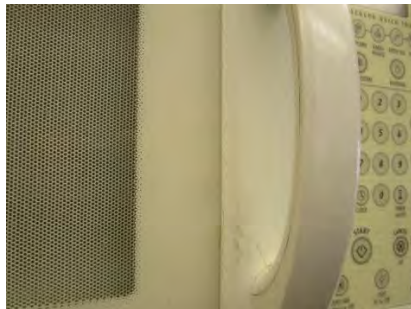
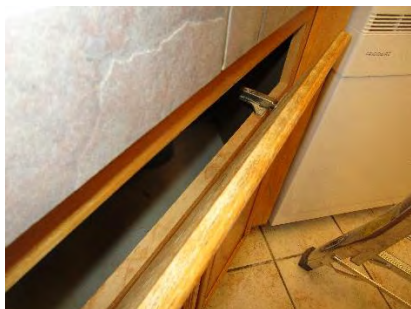
Garbage disposal in kitchen has debris in it, clean as needed.
 Kitchen dishwasher airgap cover on sink is loose, repair as needed.
 Kitchen sink has minor chip, repair as needed.
 Kitchen window south wall is stuck closed, repair as needed.
 Kitchen microwave door has cracking and range light is inoperable, repair or replace as needed.
 Kitchen flip down drawer in front of sink is missing plastic item holder, repair as needed.

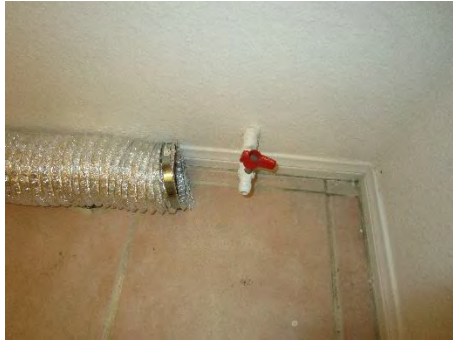
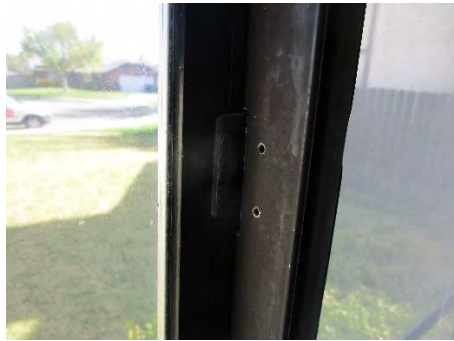
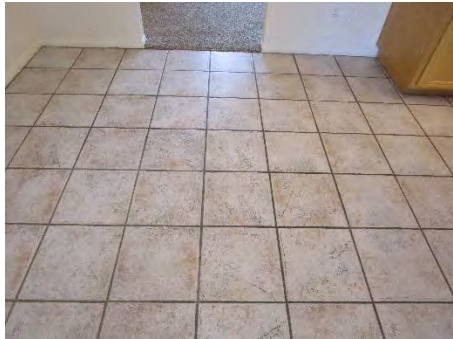
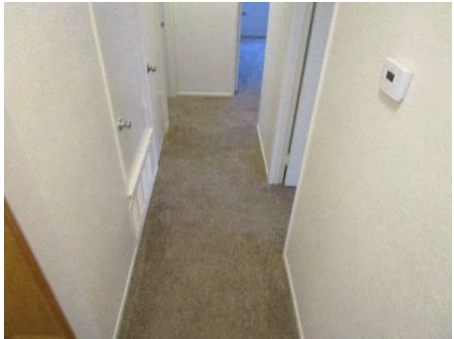
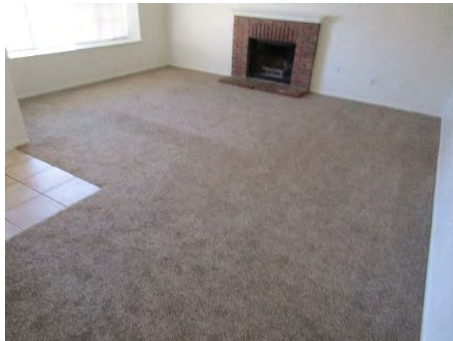
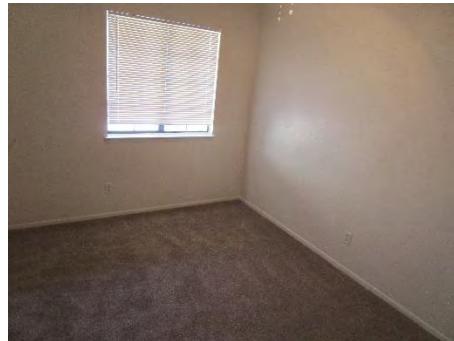
Dining room ceiling receptacle is inoperable, repair as needed.
 Living room window is missing locking hardware, repair as needed.
 Laundry room dryer gas valve is required to be capped off when not in use, cap as needed.

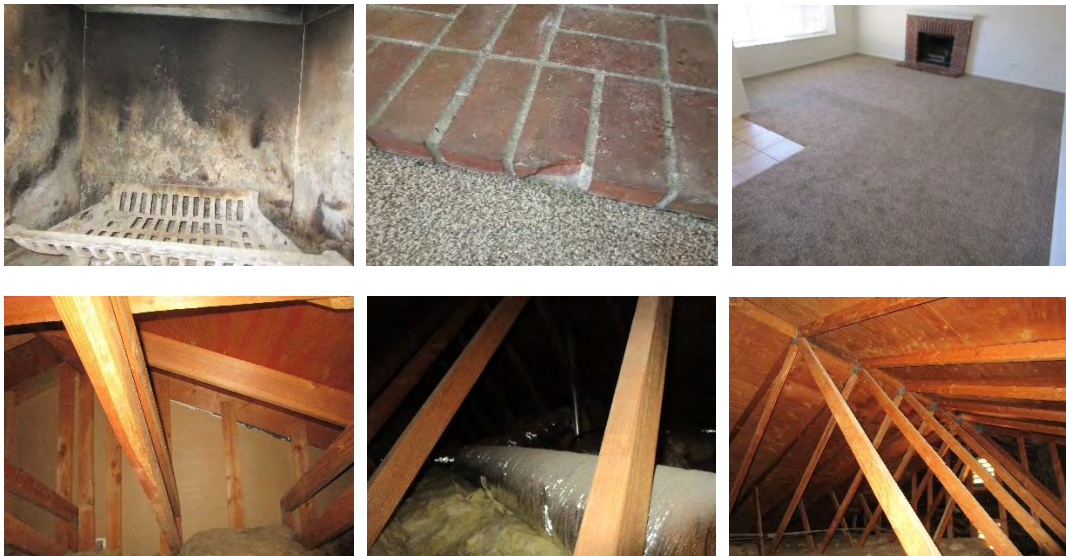
Recommend replacing fireplace panels, replacing broken hearth brick, install glass doors, and cleaning flue, repair as needed.

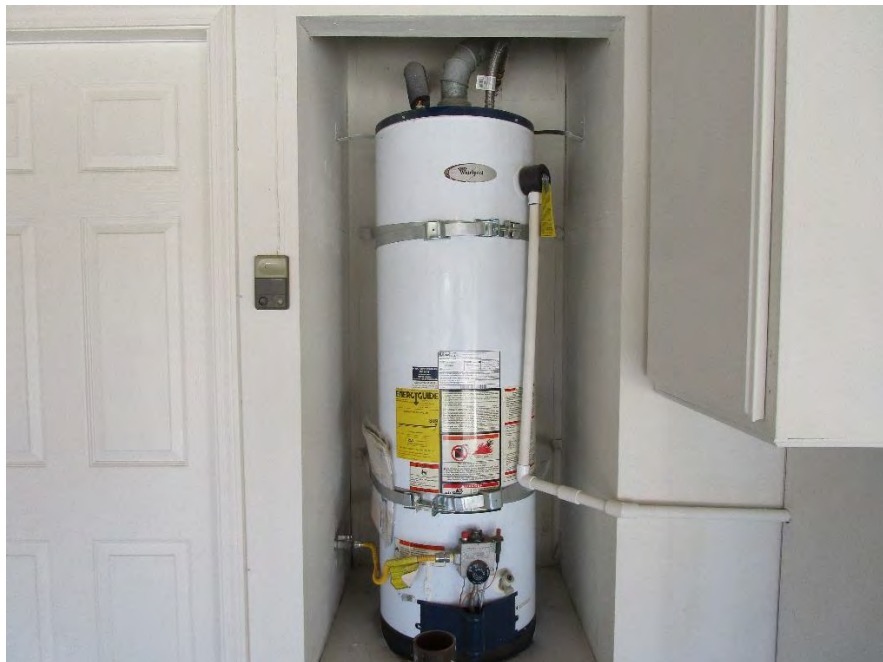
Water heater was functioning satisfactory at time of inspection.

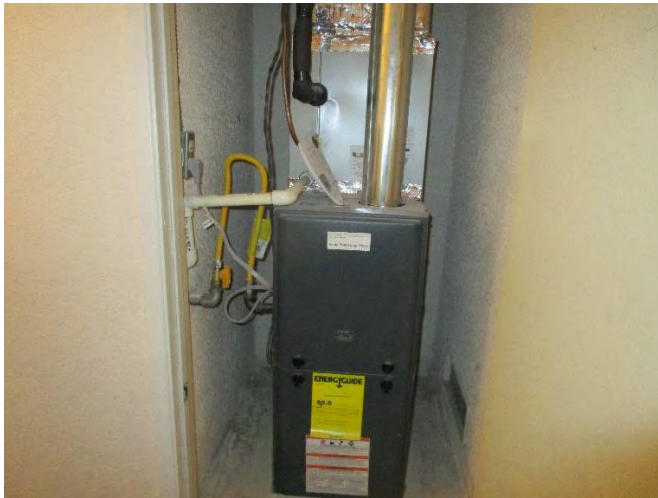
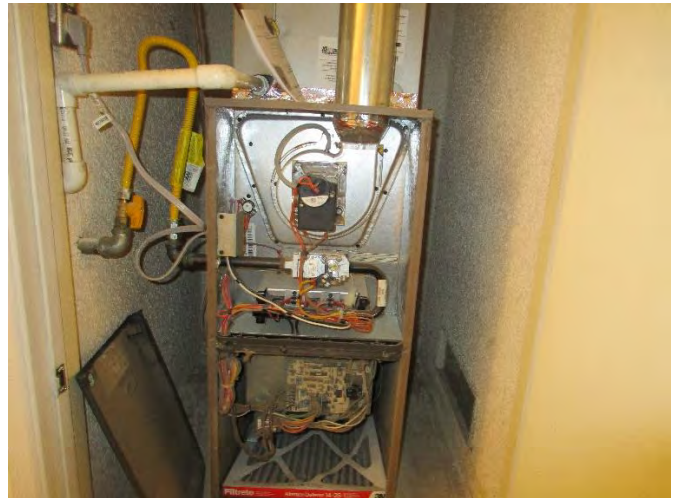
Furnace was functioning satisfactory at time of inspection.

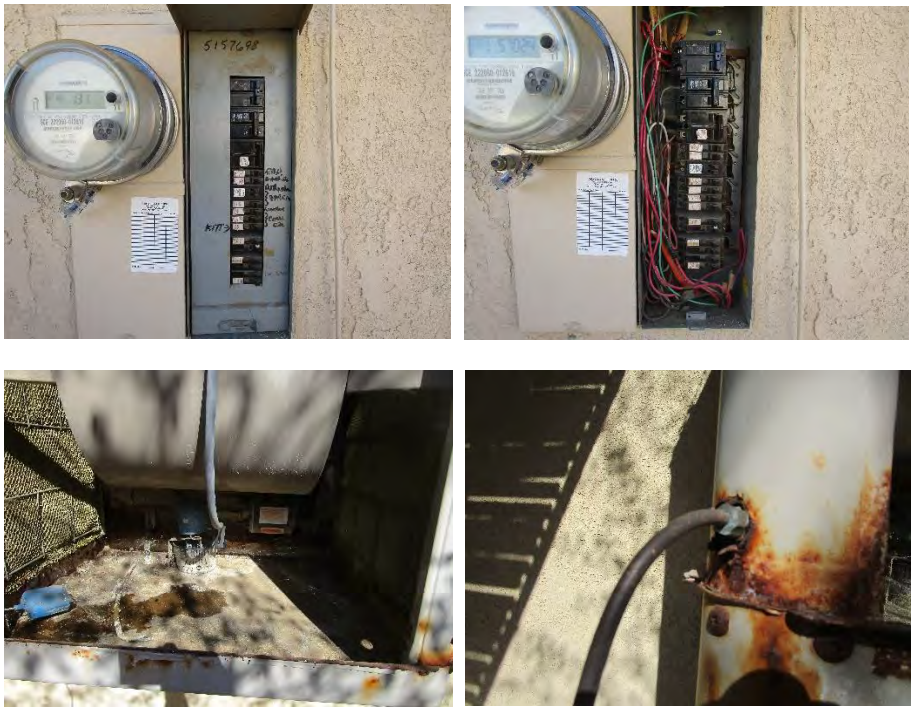
GENERAL COMMENTS
 Main electrical panel has breaker opening on cover, snap in blanks required, install as needed.
 Evaporative cooler is reaching its lifespan its rusting and requires water feed repaired and servicing, replace or repair as needed.
